CIVIL AERONAUTICS BOARD

AIRCRAFT ACCIDENT REPORT

NORTHWEST AIRLINES, INC.,
LOCKHEED ELECTRA, L-188C, N 137US,
O'HARE INTERNATIONAL AIRPORT
CHICAGO, ILLINOIS, SEPTEMBER 17, 1961

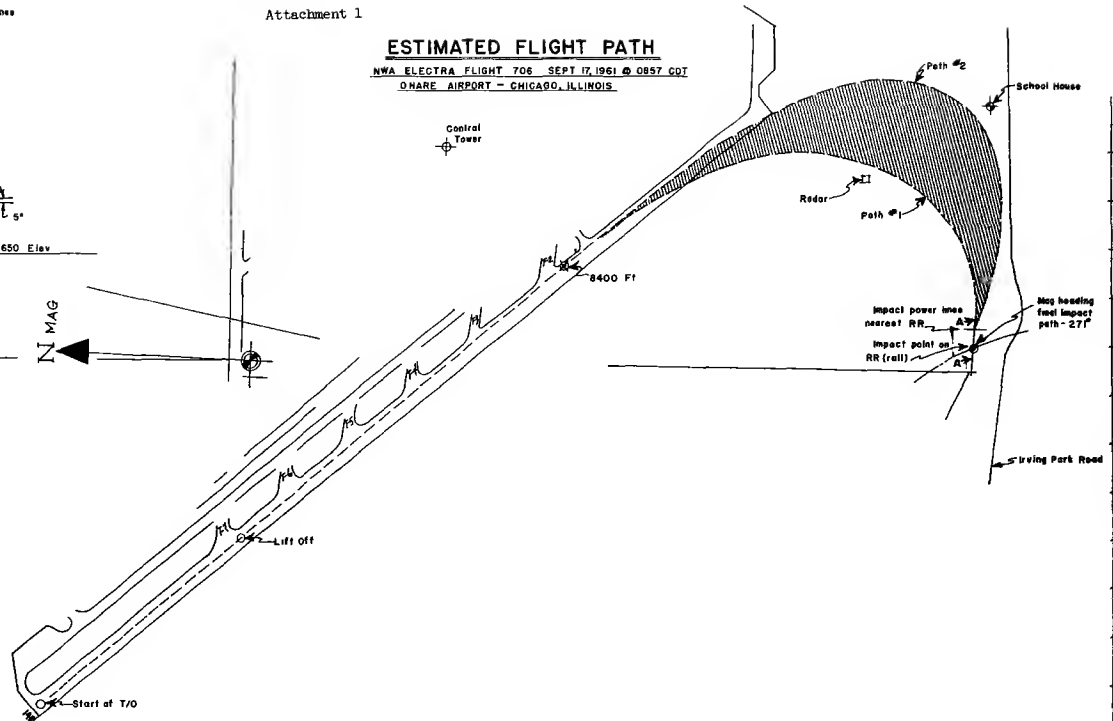
ESTIMATED FLIGHT PATH

To assist in developing a flight profile based on actual operation of Electra aircraft, tower personnel, at the request of Board investigators, conducted a survey of 44 Electra takeoffs. These takeoffs were sampled at random and were all observed when using runway 14R. The survey disclosed that the average lift-off was made when these aircraft were approximately 4,000 feet down the runway, and that when they reached the 8,000-foot marker, their altitude and airspeed indications were about 280 feet and 158 knots respectively. The airspeed was based on 28 pilot reports given to the tower. In addition, Lockheed Aircraft Corporation, in response to the Board's request, provided a study of the flightpath based both on L-188 performance data and information disclosed during the investigation. Their study encompassed a ground envelope of reported flightpaths but, based on performance data, the inner boundary was considered as the only possible flightpath. Based on the Lockheed study, Board investigators prepared the estimated flightpath chart. See Attachment #1.

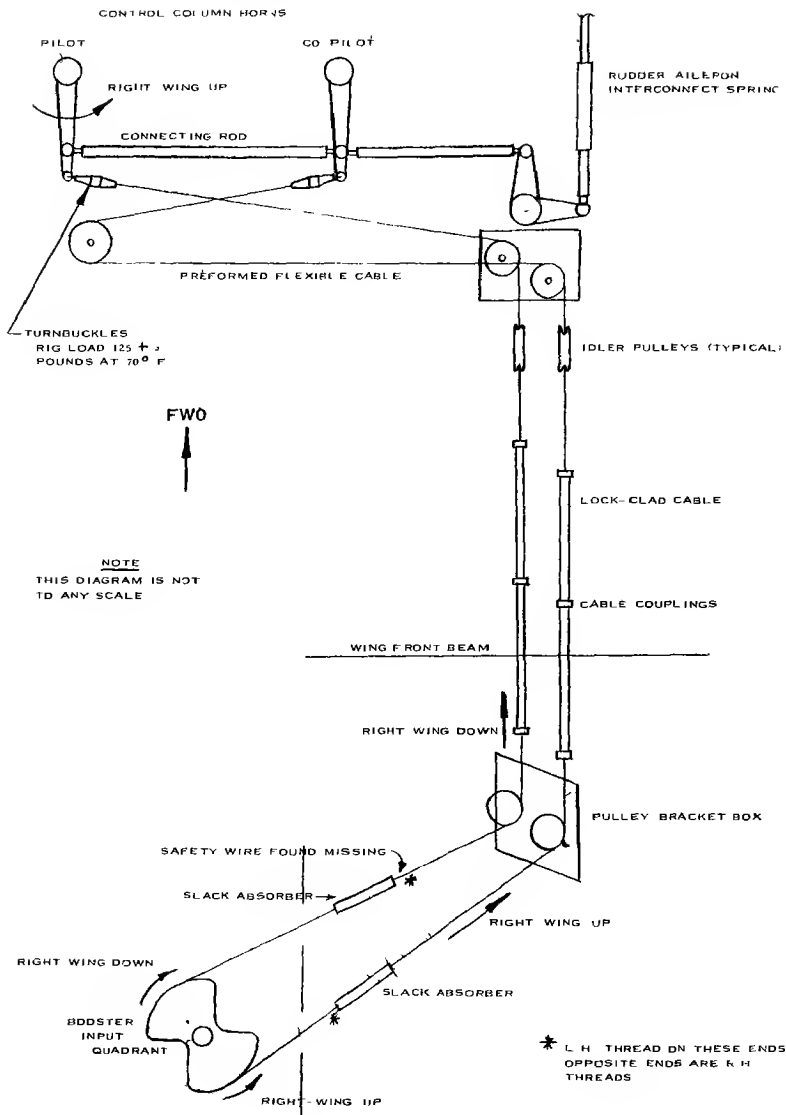
AILERON PRIMARY CONTROL SYSTEM

From the aileron boost unit's input quadrant to both control wheels, the aileron primary control system consists of two cables which run through a series of pulleys to the control wheels, forming a closed loop.^{3/} The cable which connects to the pilot's control horn is in tension for a right wing down control movement and the cable which connects to the copilot's control horn is in tension for a left wing down movement.^{4/} These cables provide a signal input from the control wheels to the boost unit when the boost is engaged, and they also provide the physical link between the control wheels and the ailerons for manual operation when the boost is disengaged.

The pilot's cable run starts with a 153.53-inch run of flexible cable routed athwartship to a pulley at Butt Line 34R, Water Line 128.5. From here, the cable consists of two consecutive 205-inch lengths of lockclad cables which run aft and down to a point just in front of a pulley bracket at Fuselage Station No. 651. A 39.25-inch flexible cable then joins the lockclad and passes through a 0.6-inch diameter guide hole in the front of the pulley bracket at Fuselage Station No. 651 and connects by a left-hand threaded stainless steel connector 4.2 inches long into the forward brass terminal block of a slack absorber unit. Proceeding from the aft brass terminal block of the slack absorber is a stainless steel, right-hand threaded connector attaching to a 42.01-inch length of flexible cable with a swaged ball fitting at the end which connects on the aileron boost input quadrant.

The copilot's cable is routed athwartship with a 200.34-inch length of flexible cable to a pulley at Butt Line 16.7L and then returned to the right side to a pulley at Butt Line 35R, Fuselage Station No. 127, and Water Line 132. From here aft, the run consists of lockclad cables identical with and parallel to the pilot's cable, and approximately an inch outboard. Just in front of the pulley bracket at Fuselage Station No. 651, a 43.75-inch flexible cable connects to the lockclad and passes through a 0.6-inch diameter guide hole in the front of the pulley bracket approximately one inch to the right and one-half inch below the pilot's flexible cable guide hole. After this, it joins a slack absorber unit with identical stainless steel fittings as on the pilot's side except that the forward one is right-hand threaded, and the rear, left-hand threaded. A 28.88-inch flexible cable with a swaged ball on the end connects the cable to the aileron boost input quadrant.

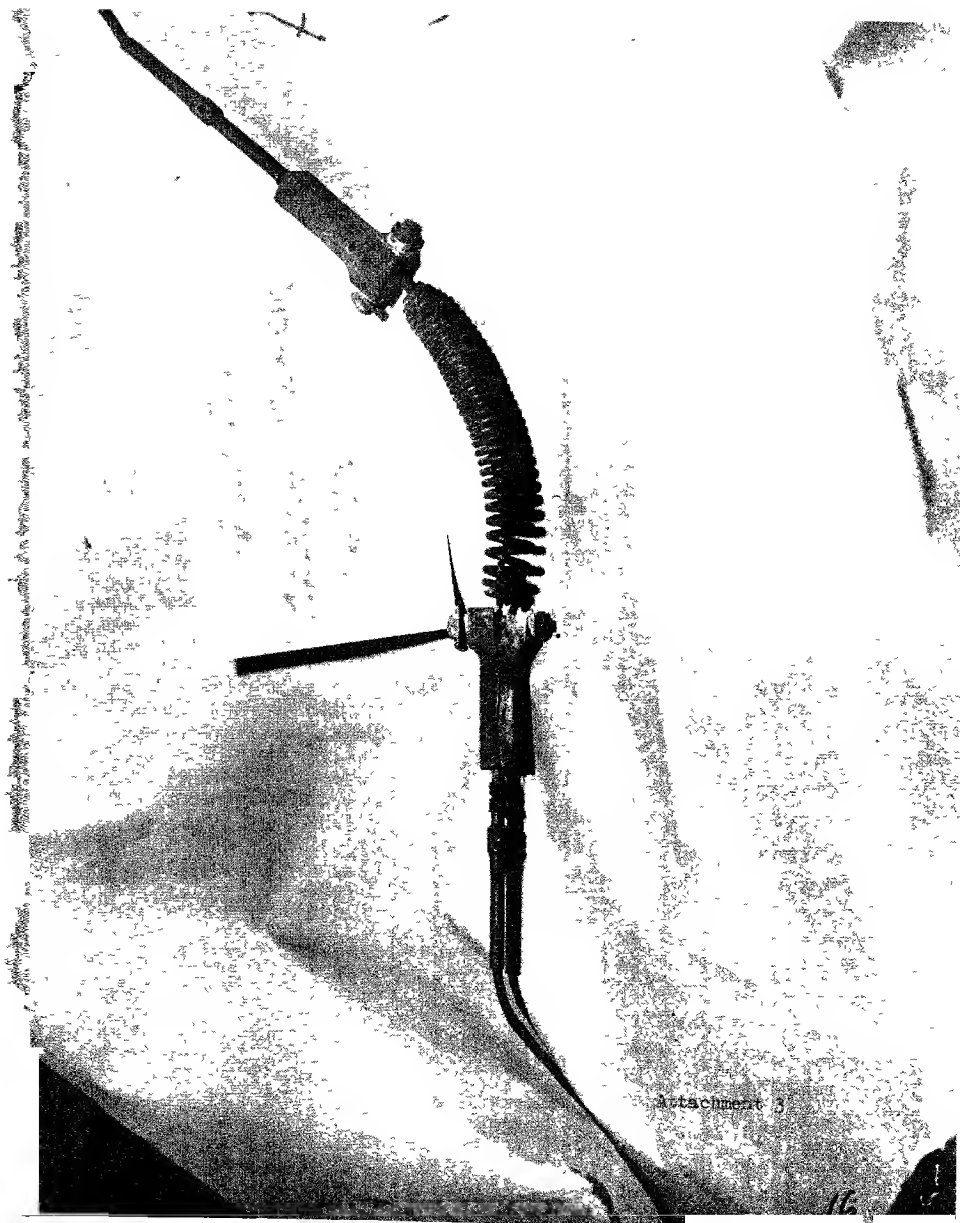
Attachment 3

Between the pilot's control column horn and the aileron boost input quadrant, all recovered cable connections were found to be normal except for the threaded connector of the slack absorber forward terminal block. This connector was found unsafetied and was backed out of the terminal block, showing five to seven threads

for a 0.40-to 0.45-inch engagement.^{5/} This slack absorber unit, minus its aluminum side plates, is shown in Attachment #3. The forward connector (shown on the right in Attachment #3) should be safetied with steel wire exactly like the aft connector (on the left in Attachment #3). Distinctive lines on the surface of the slack absorber's aft connector showed where safety wire had shielded these surfaces from fire and soot. In contrast, no such distinctive lines could be found on the forward connector in question. Laboratory examination by the National Bureau of Standards and the Federal Bureau of Investigation revealed no evidence of safety wire having been recently installed on this connector.
